MuPix11 Quality Control

Ensuring Functionality of the Mu3e Pixel Sensors

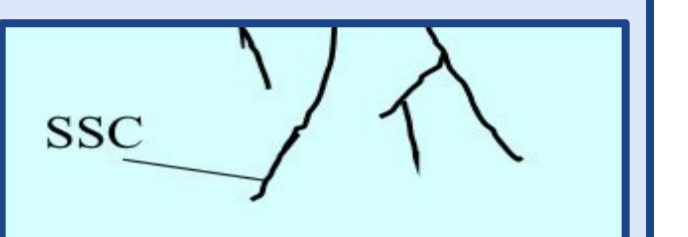
Challenges of Thinned Sensors:

- Warping
 - Increases handling damage
- Sub-surface cracks (SSC)
 - Increased leakage current
- Increased handling damage
 - Reduced yield
- Increase in leakage current if the depletion zone reaches the (SSC-) damage layer.

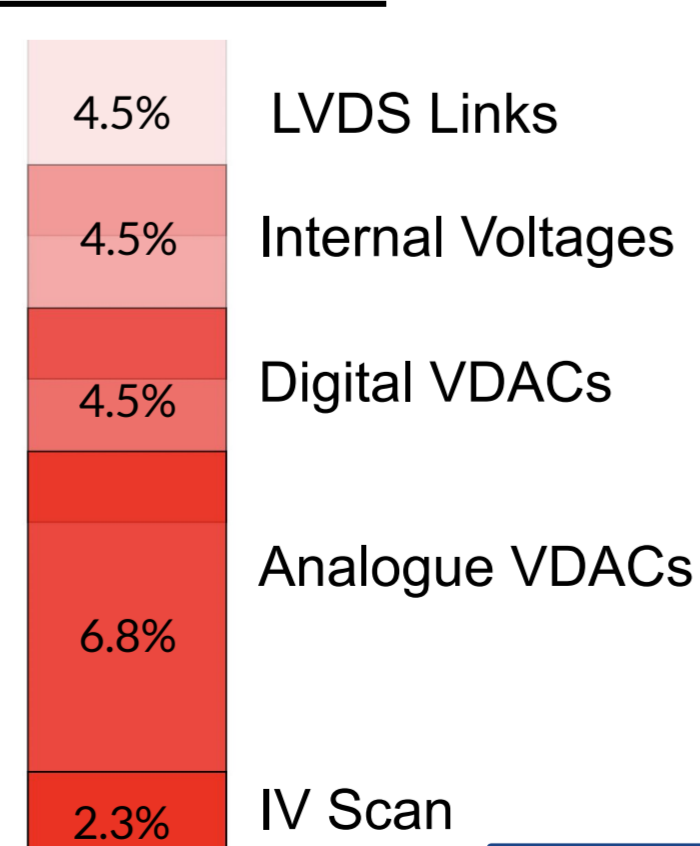
Testing Profile: 70 μm

70 μm MuPix11

- Yield: 66%
- Most common failures:
 - Physical damage
 - VDACS
- Differences to 50 μm :
 - Fewer damaged sensors, fewer failures
 - Thicker silicon layer
 - ⇒ reduced handling/production damage?

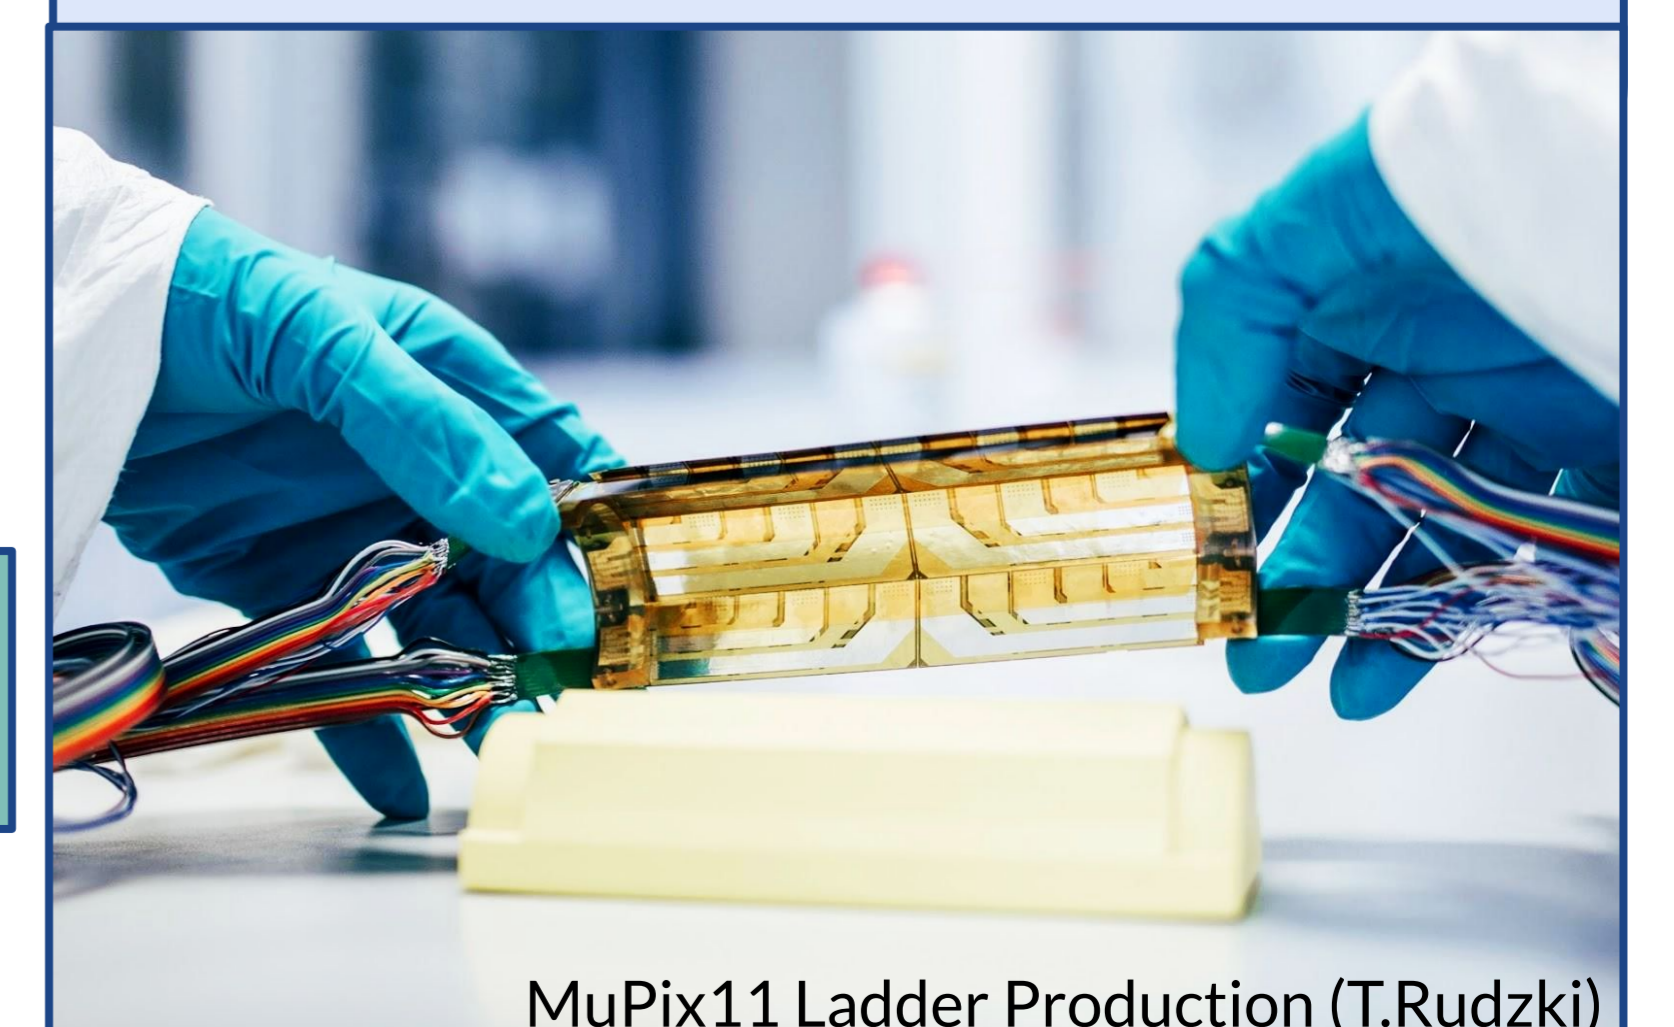
MuPix11 Ladder Production (T.Rudzki)

Vertex ladder production begins

- Installation of first verified MuPix11 sensors on ladders
- Development of a quality control procedure for ladders
